Driveshaft CV Joint Replacement

Model & year: 97-03 5-Series, U.S. (8 and 6-cylinder models)

Date: August, 2014

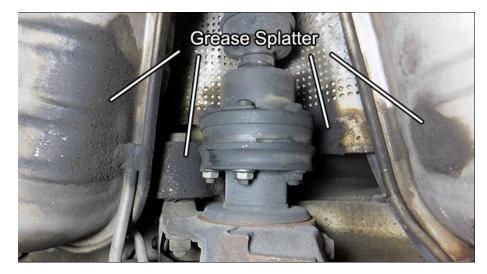
Does the underside of your 5-series, where the end of the driveshaft meets the differential, look like this?:

If so, you probably have a failed CV joint gasket which is allowing grease to leak, forced out by the centrifugal force of the spinning driveshaft. Depending on how long it's been leaking, the CV joint (Constant Velocity) may no longer be getting proper lubrication. The leak seems to come from the nuts holding the CV joint to the differential's input flange.

Based on your preferences, you may either: 1) replace gasket only, then repack joint with grease, or 2) install new CV joint and gasket. Either option requires almost the same amount of work.

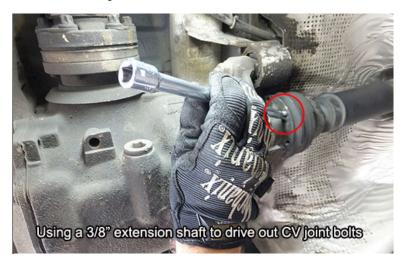
Since these bolts are press fit into their respective holes, considerable force must be applied. And since the body of the differential gearbox prohibits applying a hammer directly onto the rear of the bolts, use an extension (such as a 3/8" drive extension) from the right (passenger) side of the differential. A few strong blows with a heavy hammer to the end of your extension should release the bolts. See image below:

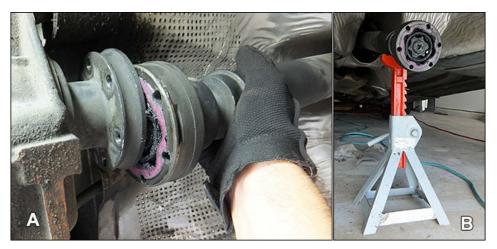
Note the purple-colored gasket attached to the CV joint in images above. This is the gasket in need of replacement.

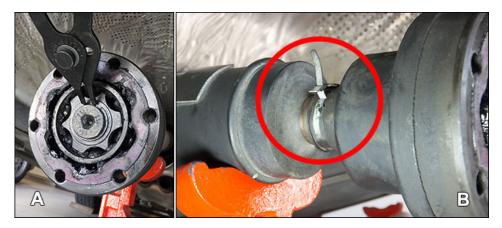
1) Remove snap ring from driveshaft (image A below) and the joint's boot clip (image B below).

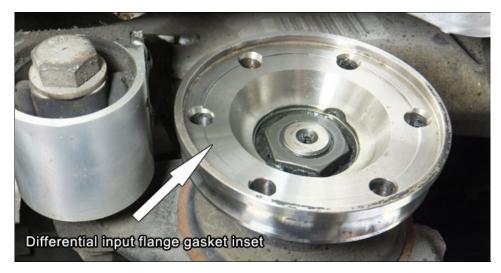
NOTE: The gasket will ultimately reside within an inset area cut into the surface of the differential's input flange as shown in the image below. When installing, placing the gasket on new CV joint instead of on flange inset allows you to better monitor gasket as new CV joint is moved into final position.

TIP - Applying a thin layer of grease to the back of the gasket will help it stick to the CV joint during installation.
