Window Motor Repair

- **Model & Year:** 97-03 5-Series
- **Expertise:** Intermediate
- **Date:** September 2014
- **Updated:** May 4, 2024
- **Time Estimate:** 4-6 hours

5 Series ^{E39}

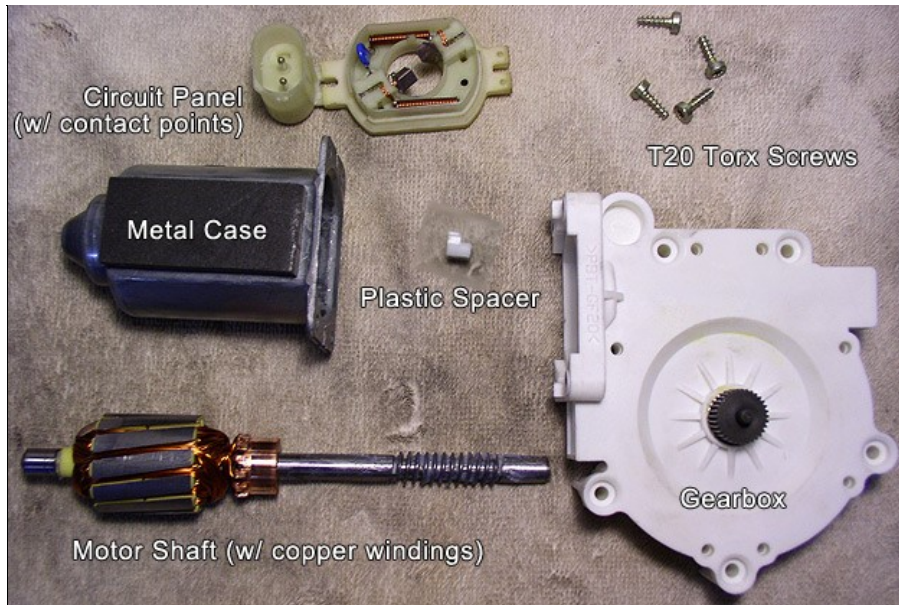
Inside the motor's metal case is the problem source: fouled contact points. These points are sometimes called "brushes" and are a common source of failure on electric motors. Specifically, the rotating copper contact area on the motor shaft becomes fouled with residue from the fixed contact points (brushes) as they wear down over time. Cleaning this area restores good contact and resolves the problem.

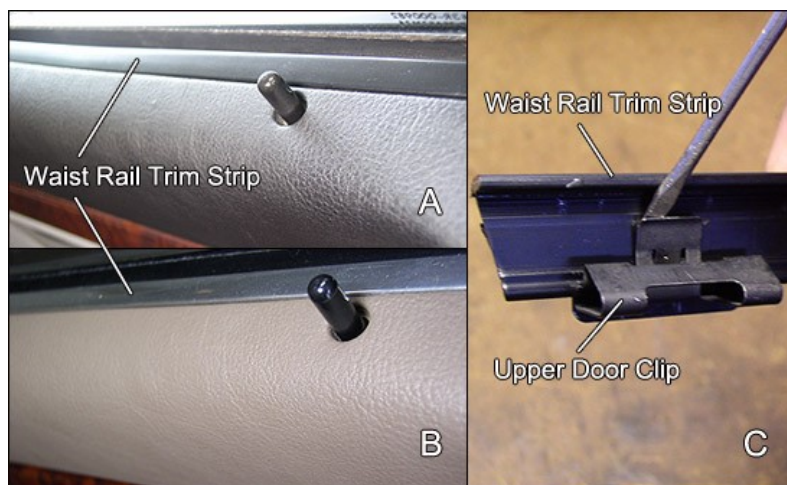
Perhaps the most challenging aspect of this repair is removing the door panel undamaged. The panel is held in the upper door clips by trim which is very difficult to remove. *This is not mentioned in service manuals.* In BMW parlance this trim is called the "waist rail trim strip" or "belt moulding" (image panels A & B below). It should be pried from the clips (with its attached weather strip) before panel removal (image panel C below).

The door panel's inner retaining form has a ridge which fits into slots on the upper door clips. If the panel is forced off the upper clips without first removing the trim, the panel retaining forms may separate from the panel and have to be glued back on prior to installation. This is a very, very common failure point on BMW door panels.

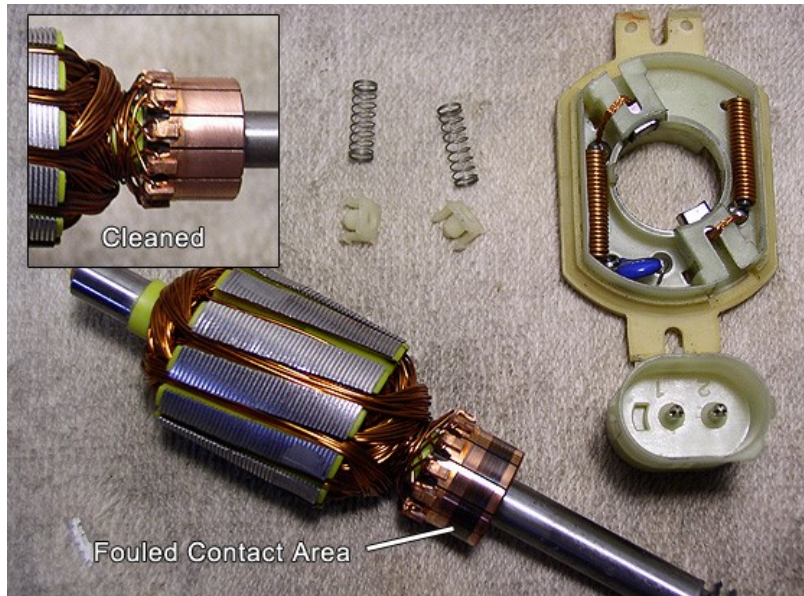
7) Inspect and clean shaft's copper contact area:

NOTE: Contact points are wear items. If under 1/8" length remaining, consider motor replacement. Such short nubs may become dislodged during reassembly (step 10 below), resulting in noisy motor operation. Ask me how I know!

We've finally reached the heart of the problem. Using steel wool or equivalent, clean copper contact area on motor shaft. See image above. Clean also contact points and metal case, and any other dirty parts. If available, use compressed air. Done!
