# Window Regulator Rebuild

- **Model & Year:** 99-03 5-Series, U.S.
- **Expertise:** Intermediate
- **Date:** August 20, 2023
- **Updated:**
- **Time Estimate:** 3-6 hours

# 5 Series E39

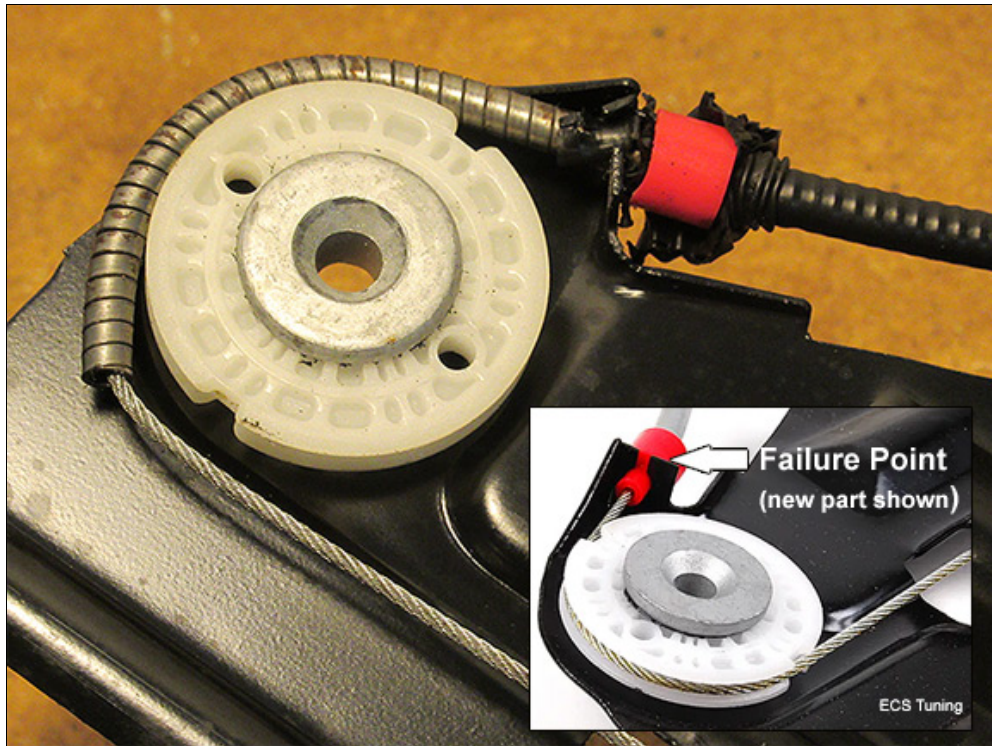
Unlike E38 7-series regulators which suffer failed pulley wheels, the problem on E39 5-series can be caused by aged plastics. Specifically, the regulator's upper cable sheath attach point. The red plastic holder can break, allowing the sheath to pass into the pulley causing it to jam:

A generic BMW screw clip can serve to replace the broken sheath retainer. The sheath itself needs to be secured by a common cable tie, to guide the cable through the clip. Just as important, it's possible to rectify a jammed cable spool (and clean the motor's contacts). In this way, you can effectively rebuild your entire regulator without resorting to cheap aftermarket alternatives!

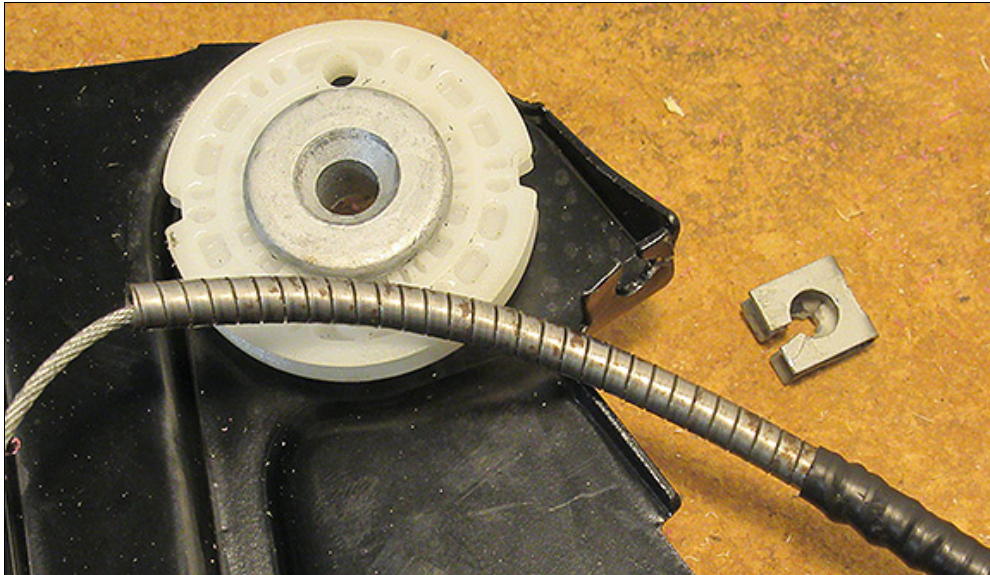
- 5) Using a trim saw or Dremel tool, cut away failed sheath retainer. Then remove any bunched plastic on the metal sheath around the failure point.
- 6) Notch the open end of a BMW screw clip using a Dremel tool or similar. This notch provides a cable passthru:

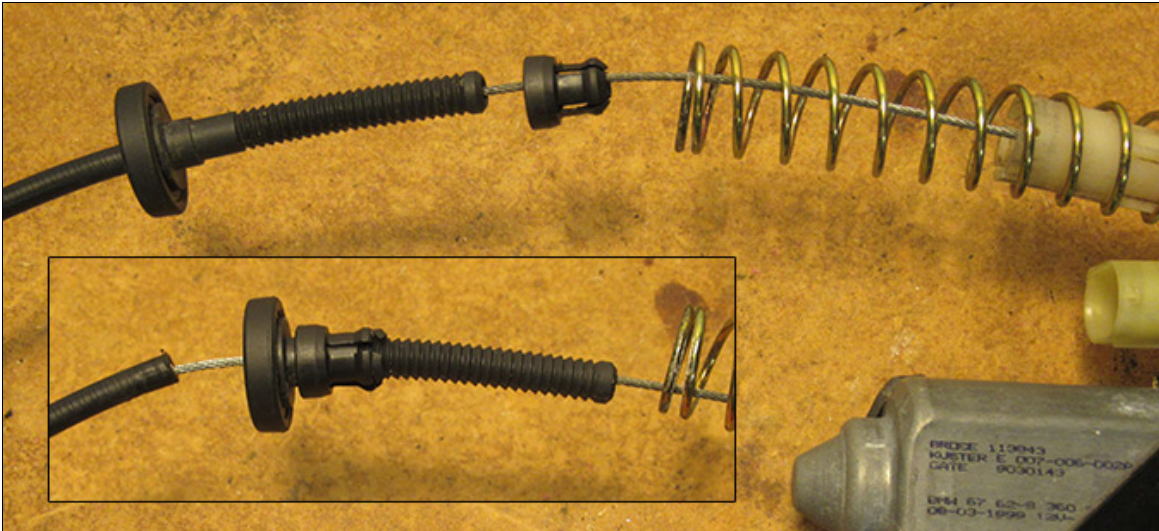
**7)** To prepare regulator for the repair, the sheath tension spring needs to be fully compressed. This first requires the cable guide clip be extracted from the white plastic spool housing and slid completely upwards toward the black retainer cap:

Now loosely insert the black retainer/guide into spring, and seat the spring over spool housing.

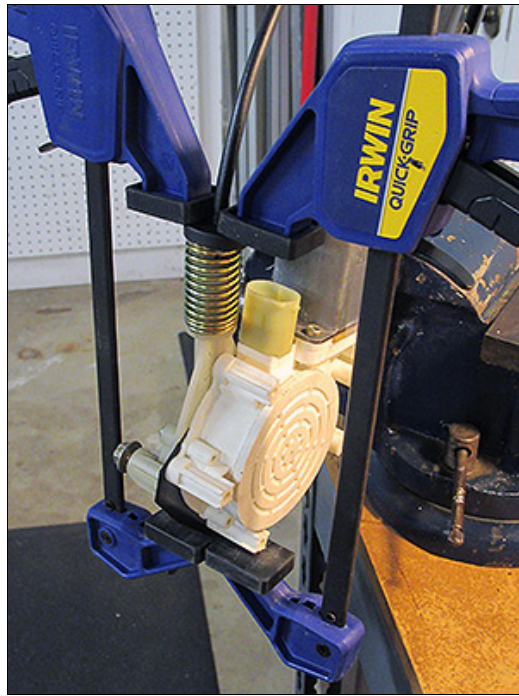
**8)** Improvise a spring compression method, such as employing a pair of clamps positioned over the black retainer cap, while holding the regulator frame in a bench vise:

Otherwise use a helper to hold the spring in a compressed state while the repair is completed. Be sure to guide cable into spool housing as spring is compressed.

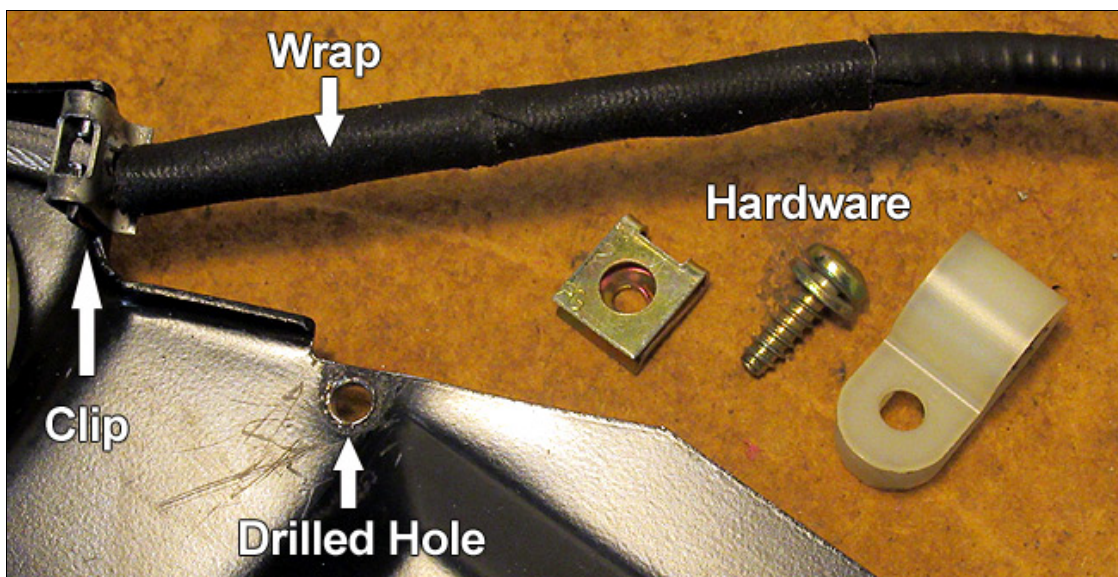
**13)** To guide the cable through clip and secure the sheath, drill and deburr a small hole in regulator frame near clip for placement of a common cable tie:

Use a drill press if possible, for accurate results. The hole size should of course match the size of screw to be used.

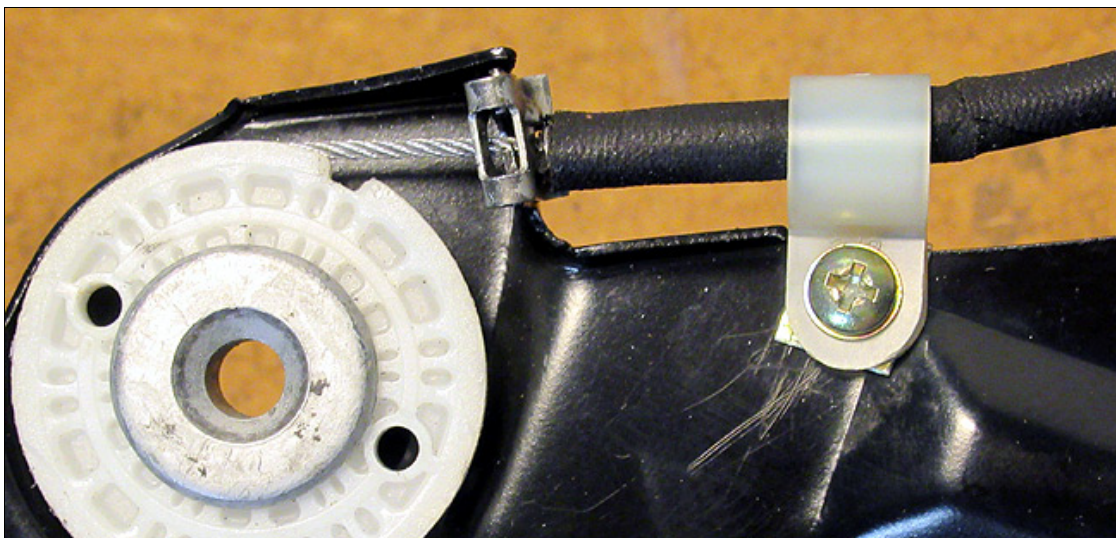
**14)** Secure sheath using cable tie hardware, tightened securely to regulator frame:

If you wish, wrap additional material around sheath to secure it snugly inside cable tie.
