• Lumbar Valve Replacement

Model & year: **95-01 7-Series, U.S.**

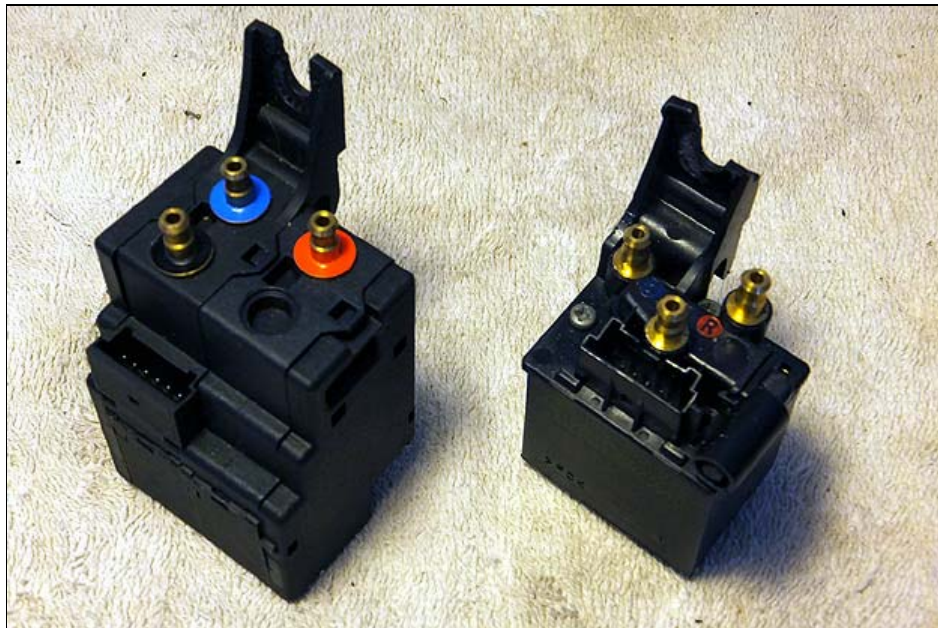
- (1) Lumbar Valve Unit, p/n 67 66 8 385 632 list: \$129, used: about \$25 (samples shown above)

I discovered the valve units come in at least two different sizes and are interchangeable (see image above). New valve units are expensive so many turn to used parts instead. The seatback panel will need to be removed for access.

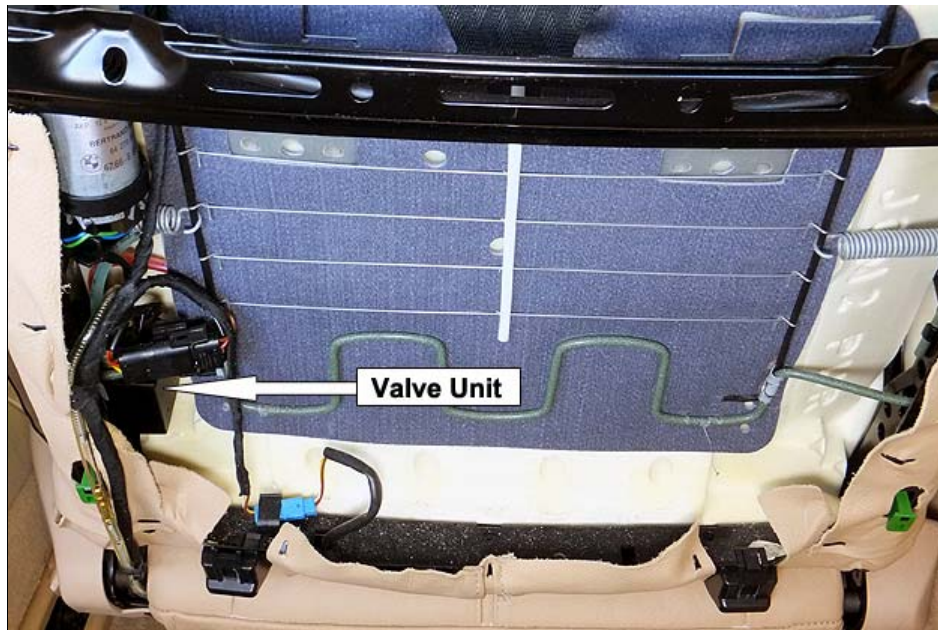
- 3) Locate the valve unit in lower left of seatback. See image:

The valve unit will be partially hidden by various other wires and connectors; unplug and move them out of the way.

The air line which is clear or transparent is the main air supply coming from the air pump under the seat, while the blue line controls the upper lumbar chamber and the red line controls the lower chamber. (See image below.)

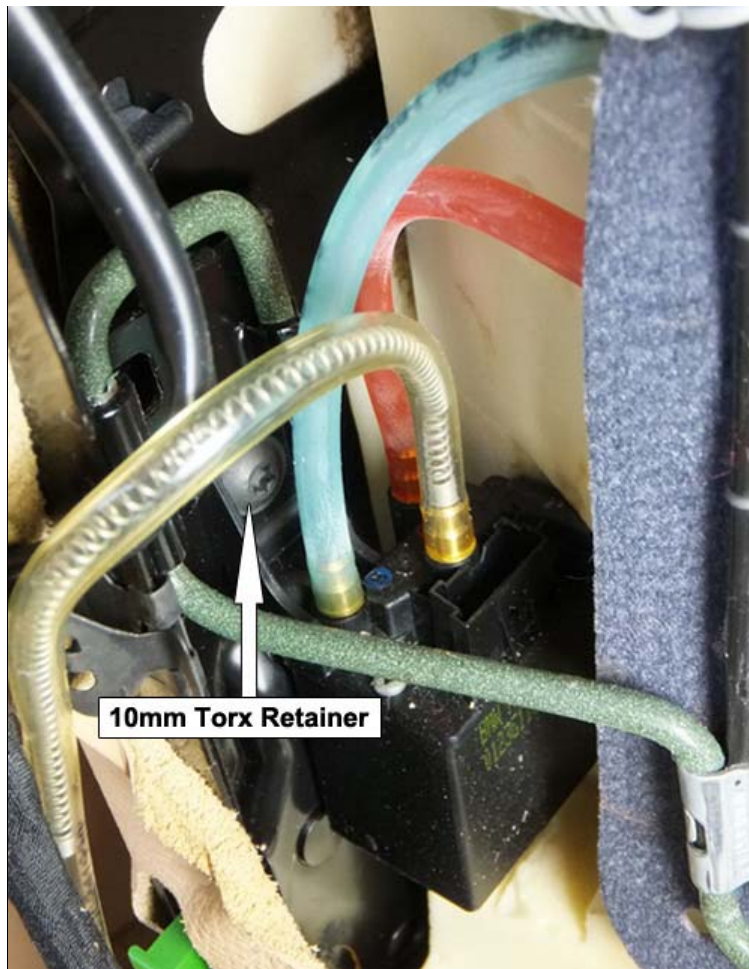
- 4) Unplug valve unit electrical connector. Prying carefully with a small screwdriver for leverage may help in this confined space. Needle nose pliers may also help remove the plug.

5) Remove the T10 torx retainer screw and pull valve unit up and off its retaining slot in the seatback frame. See image above. Position the valve unit so that the air lines may be easily reached.

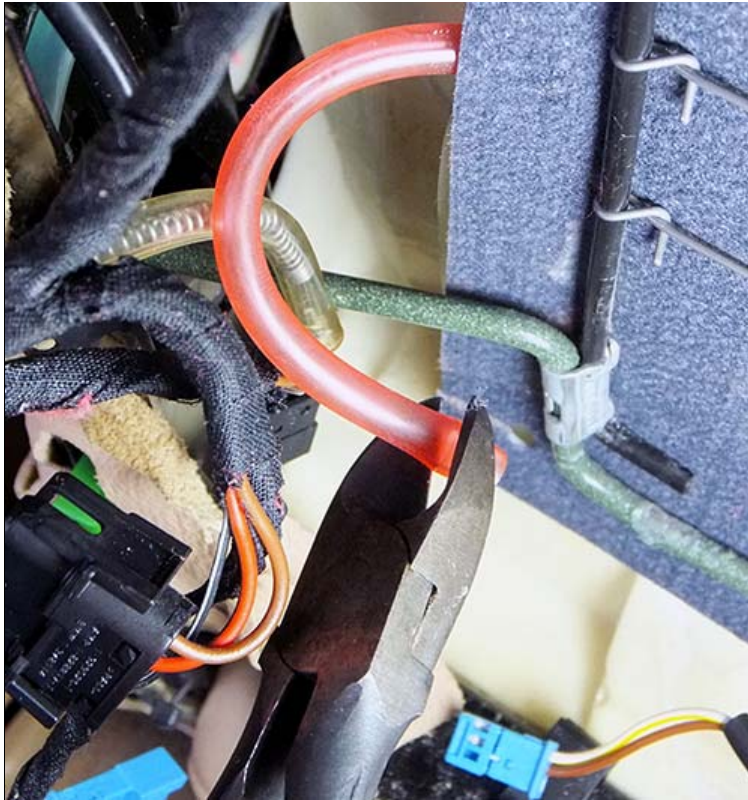
7) In order to ensure an air-tight seal with the replacement valve unit, snip the deformed, bloated ends of all three air lines where they connected to the old valve unit (if not already done in step 6), as illustrated below:
