Window Motor Repair

- **Model & Year:** 97-03 5-Series
- **Expertise:** Intermediate
- **Date:** September 2014
- **Updated:** May 4, 2024
- **Time Estimate:** 4-6 hours

5 Series ^{E39}

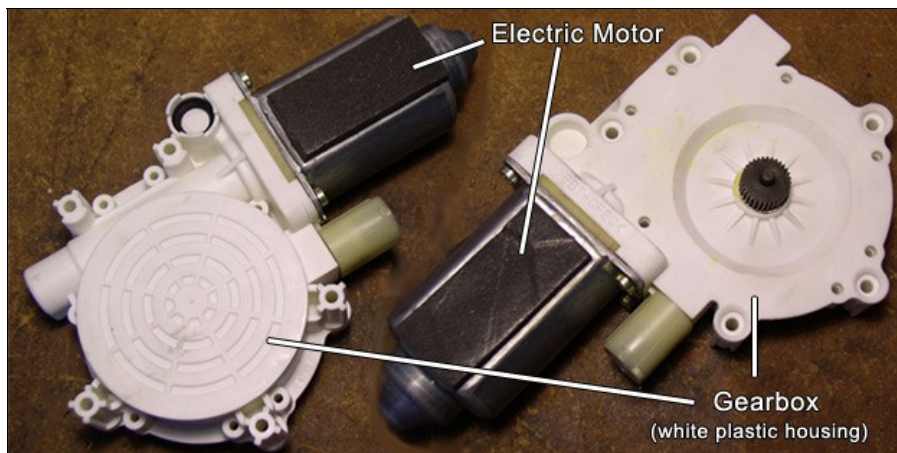
The problem resides inside the electric motor. And, I've discovered it's serviceable in place! A free fix! Only the door panel needs to be removed for access. For reference, the window motor is shown below:

It consists of two separable parts: 1) electric motor and, 2) mechanical gearbox. While the gearbox is attached to the window track/regulator mechanism, the electric motor is not. It's held to the gearbox by four T20 torx screws. Once separated, the motor's components are:

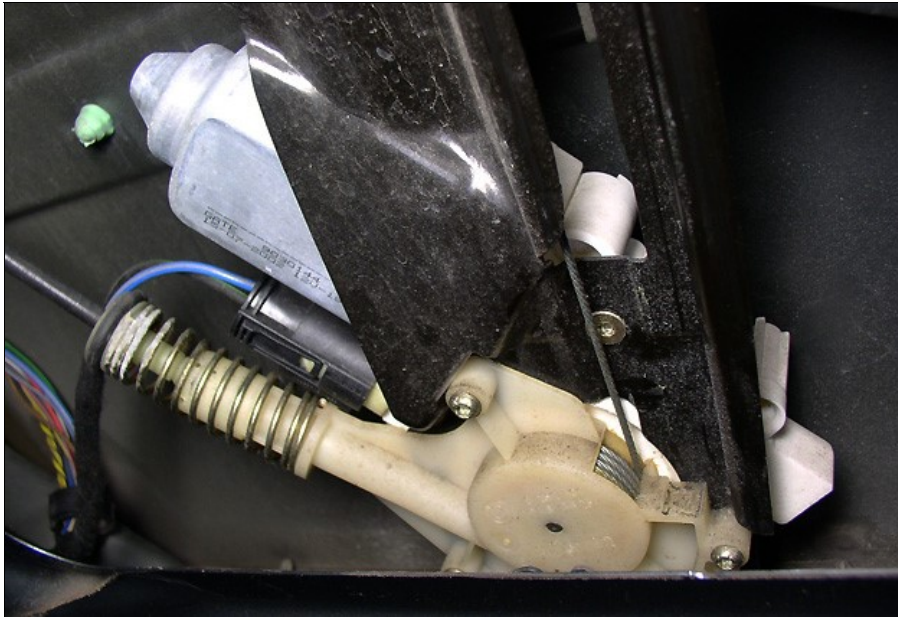
- 1) The window motor should be visible inside the door:

The motor will reside behind the black regulator frame and therefore be partially obscured. The motor's white plastic gearbox is screwed to the cable drive in front, with an attached electric plug. Remember, your car's set-up will vary depending on model year and door. (530i right rear door shown above.)

The objective is to access the silver metal case protruding from behind the regulator frame.
